FAILURE ANALYSIS OF LEAN AMINE PUMP AT A GAS COMPANY IN GRESIK

Wiwik Purwadi
Beny Bandanadjaja
M. Achyarsyah

Jurusan Teknik Pengecoran Logam
Politeknik Manufaktur Negeri Bandung
Jl. Kanayakan 21, Dago-Bandung 40135
Telp./Fax. (022) 2500241/ (022) 2502649
e-mail : wiwik@polman-bandung.ac.id

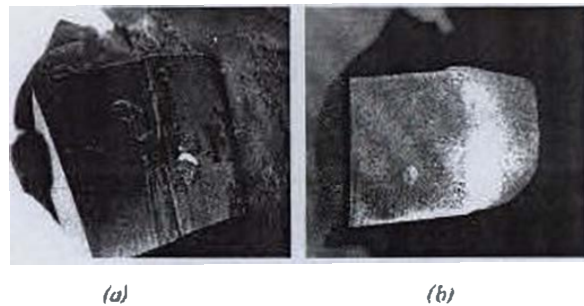
The as received bearing was carefully examined both visually and with the aid of stereoscopic microscope (magnification up to 65X). The examination covered all parts of the roller bearing. It revealed that the bearing was totally broken and experienced significant rise of temperature as indicated by the color. Almost all exposed surfaces show discoloration, wear and plastic deformations. It was interesting that the surface of the inner ring has been remarkably deformed as shown in the fig 3. Such deformed area could only be happened while the inner ring was still running. On the back side of the inner ring, at which the sleeve was attached, there was path pattern to be identified as shown in fig 4. It has indicated that the sleeve still ran on the inner ring after the bearing was totally blocked. It increased subsequently the temperature of the inner ring, which furthermore lead to the decrease of the hardness.

Figure 3a and 3b. Deformed area around the race way of inner ring

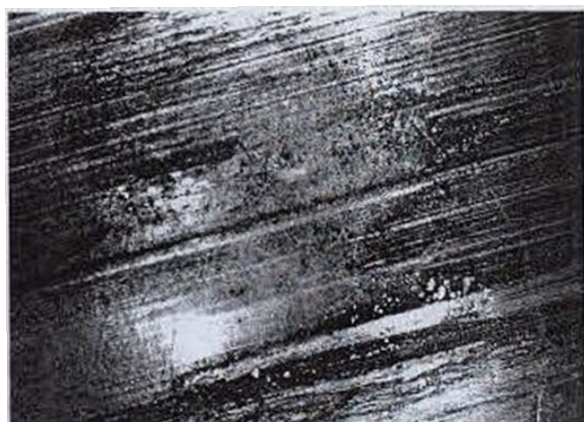
Figure 4. Path pattern on the backside of inner ring

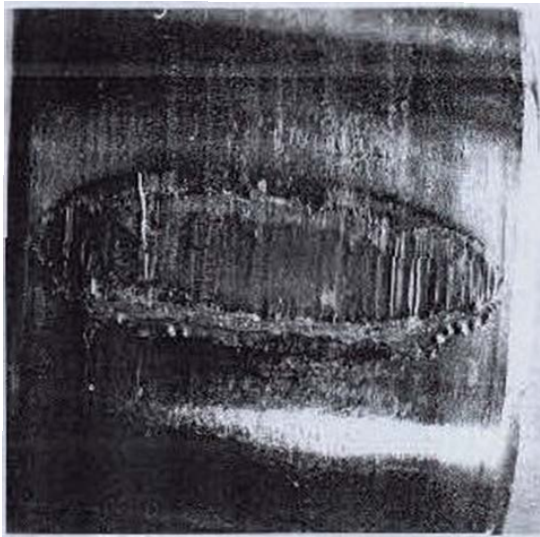
Figure 5a. Strong deformation on the surface of the Rolling element

The strong deformed area did not have any indication of comet. The deformation happened when the bearing had stopped.

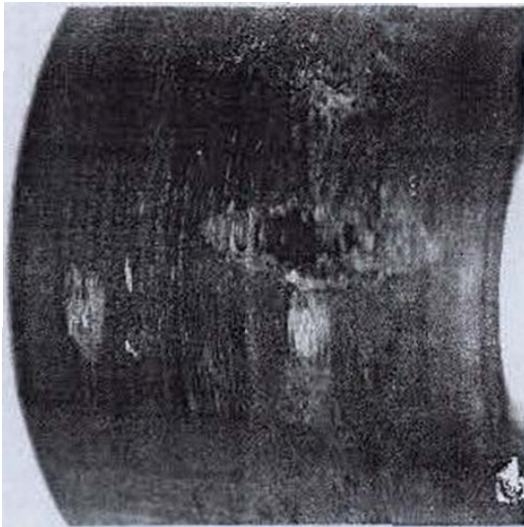
Figure 5b. Light deformation on the surface of the Rolling element

The light deformation on the surface of the rolling element indicated loads due to vibration while the bearing was still running.

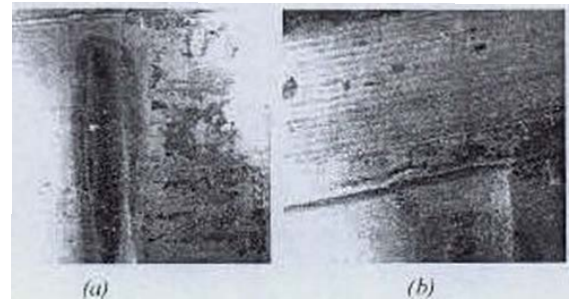
The inner ring experienced strong deformation caused by the high pressure of rolling element as shown in fig 4a and 4b. The curve of the deformed area matched to the curve of the rolling element (outside diameter of the rolling element). Considering the shape of the deformed area and the color of the inner ring, the deformation took place after the bearing totally blocked and the temperature increased. Becker, WT and Shipley RJ (2002) described in his work "Failure Analysis and Prevention" that the increased temperature caused a softening effect to the material, which enabled the material to be deformed without any crack occurring.

Figure 6a and 6b. High temperature deformation

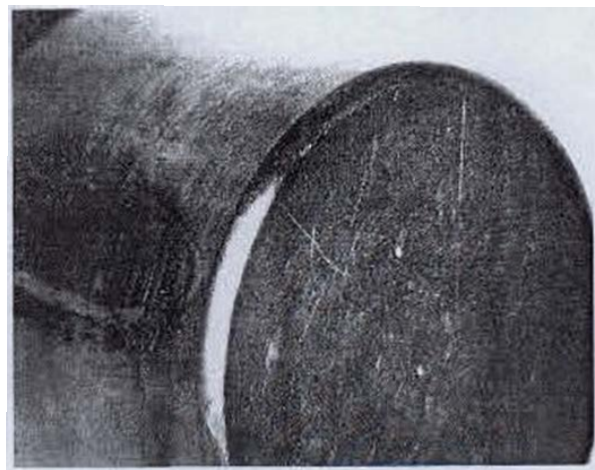
After the bearing collapsed, the rolling element experience light arcing and increase of temperature, as shown in fig 7. The positions of arcing area are similar for all rolling element.

Figure 7. Arcing on the rolling element

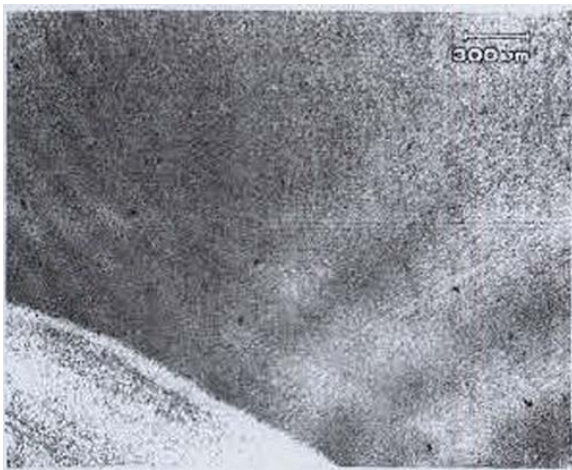
cut machine to avoid any change of the microstructure. Nital was used as the etchant after the grinding and polishing process had been completed. On the surface of large deformed area, a deposit of foreign metal has been identified as shown in fig 8. The clear cut parting line between those materials could be used as evidence that the white area is deposit material. By deeper look into the material, it could be seen that there was diffusion along the parting line as shown in fig 9. The base material of the deposit is basically similar to the material of the rolling element.

Figure 8. Deposit of material

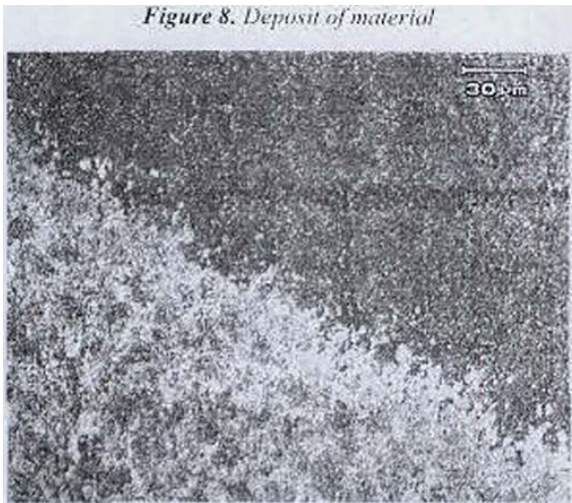
Figure 9. Diffusion along the parting line

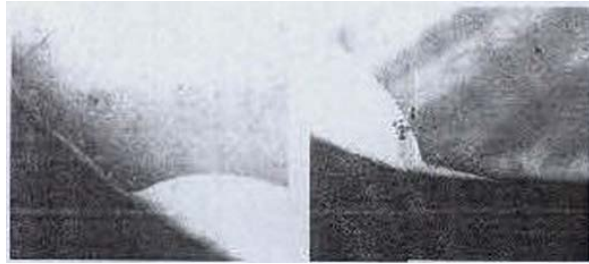
(a) (b)

The material deposit caused the blockage of bearing which then followed by the increased of temperature. The edge of the deposit as shown in fig 10a and 10b proves that there was no movement of the rolling element after the deposit material bonded on the rolling element.

Figure 10a and 10b. Deposit Material

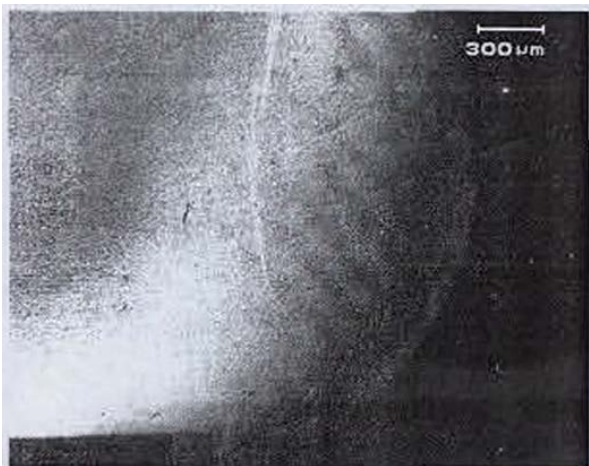
Microstructural change has occurred in the area of arcing. Gradual change of microstructure always indicates a slow increase of temperature occurred to the material (Jones, DRH, Engineering Failure Analysis). The gradual change of microstructure as shown in fig 11 indicated a slow increase of temperature. The high electrical shock is therefore not considerable.

Figure 11. gradual change at the arcing area

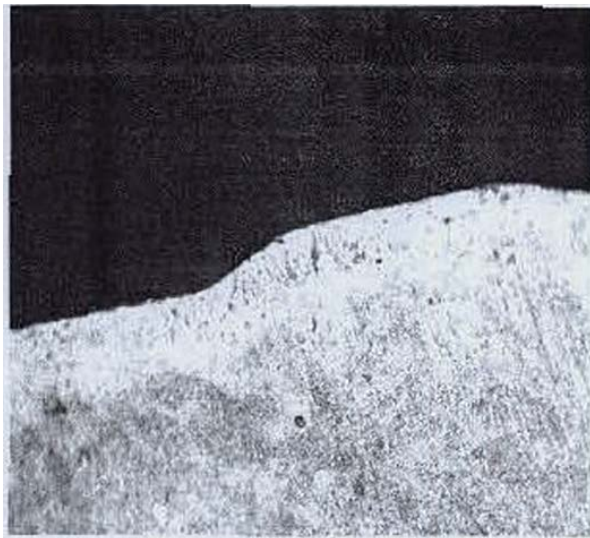
friction. Figure 13 and 14 show that the excessive heat (up to 700 °C) has caused a change in the microstructure of the inner ring. Closed under the raceway, spheroidal carbides are finely dispersed in the matrix of martensite. Away from the raceway (closed to the sleeve) austenite and martensite are to be found.

Figure 12. Smooth surface of the uniformly deformed area of the raceway

Figure 13. Microstructure closed to the race way by different magnification

Figure 14. Microstructure closed to the sleeve by different magnification

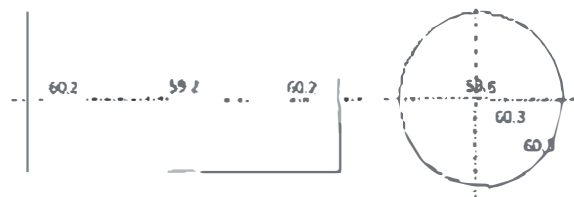
Figure 15. Hardness value of the rolling element

There was no significant difference in the hardness of the material. The surface area showed slightly higher value. In general the hardness value met the standard requirement of the bearing hardness. The inner ring experienced work hardening, which lead to the increase of hardness as shown in the Table 2 and Figure 12.

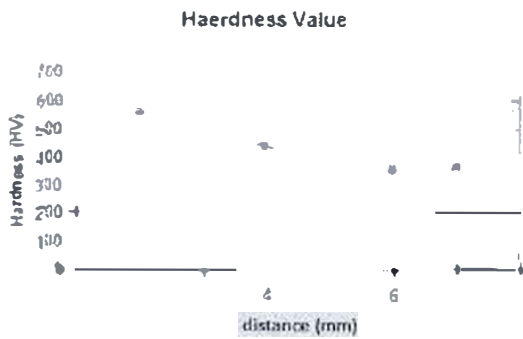
Figure 16. Hardness of inner ring

At the surface area the inner ring experienced stronger work hardening and resulted higher hardness value while the inner part of the ring experienced increased temperature and softening effects.

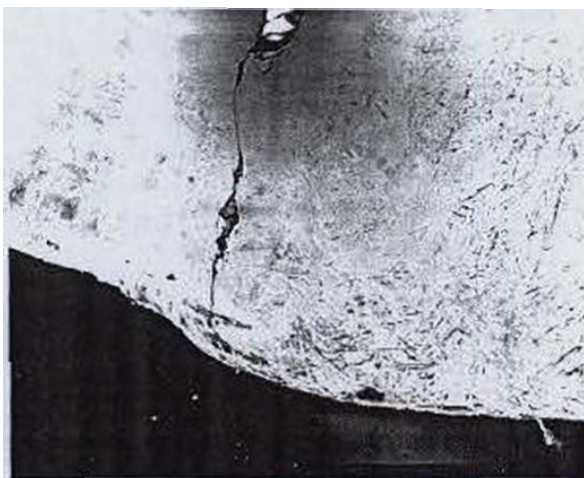
Scanning electron microscopy examination, sample was removed from the inner ring. SEM examination revealed a crack on the border of deformed area. Figure 16 shows the location of the crack and its propagation. The shear stress was caused by the deformation of the race way. The surface area of the race way experienced high compression load, which is indicated by the thin layer of deformed grain as shown in Figure 17. The smooth surface of the raceway indicated the absence of corrosive attack.

Figure 17. crack on the race way of inner ring

The purpose of research is to find out and determine the root causes of the failure and provide recommendations for further pump operation. The pump primarily deteriorated by static load at the driven end which was due to the unbalance and misalignment of the electric motor. The load caused excessive deformation and clearance on the surface of the raceway and increased the gap between rolling element and the rings, which subsequently lead to the vibration and total blockage of bearing. Excessive wear caused by abrasive material and the inappropriate lubrication is not considerable. The ambient temperature (30°C) and other parameter such as hardness value (59.2 HRC) were considerably still in range. It is recommended to conduct the alignment properly by avoiding any excessive load and knock. The platform of the pump and electric motor should be maintained and leveled periodically.

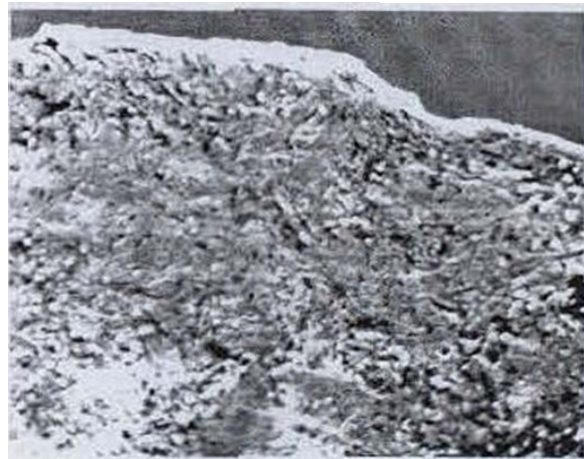
Figure 18. Thin layer of deformed grain
