FAILURE ANALYSIS OF LEAN AMINE PUMP AT A GAS COMPANY IN GRESIK

Wiwik Purwadi
Beny Bandanadjaja
M. Achyarsyah

Jurusan Teknik Pengecoran Logam
Politeknik Manufaktur Negeri Bandung
Jl. Kanayakan 21, Dago-Bandung 40135
Telp./Fax. (022) 2500241/ (022) 2502649
e-mail : wiwik@polman-bandung.ac.id

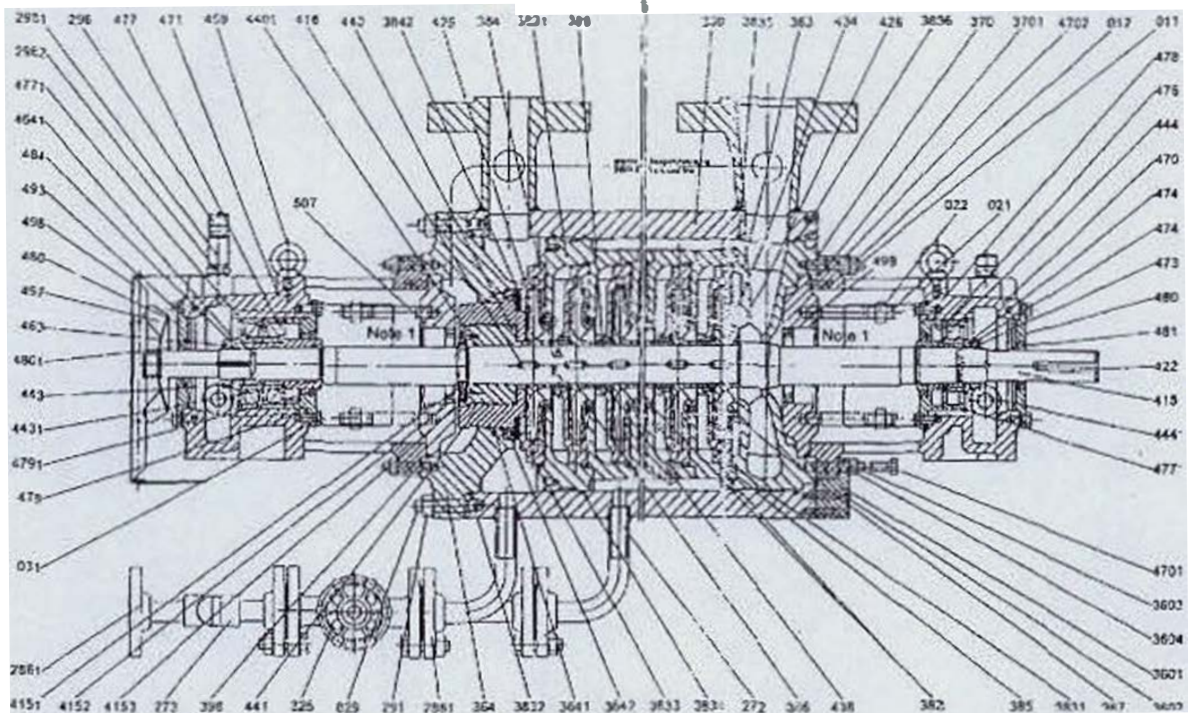
As described in the figure 1 (475) bearings at the both side of the main shaft support the shaft. At the Non Drive End a double angular contact ball bearing were mounted to retain the axial and the radial load as well as providing bearing mechanism for the rotational movement of the shaft. At the drive end a cylindrical roller bearing (indicated by red circle) was mounted to support the rotational movement of the shaft.

Figure 1. Construction of Centrifugal Pump *) Manual Instruction of Centrifugal Pump

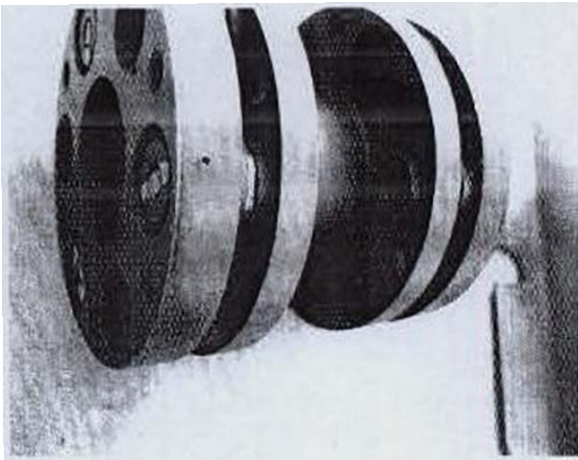
Figure 2. Flexible coupling
